## Early Works: Preliminary Glimpses of the First Military Complex at Point Henry, Kingston, Ontario, 1812-1827

Henry Cary

*In the first months of the War of 1812, work parties of Canadian militia and British regulars began clearing and fortifying the high ground of Point Henry, Kingston, Ontario. Over the next several years the temporary works were expanded and improved to become a large military complex and the chief depot for Upper Canada. However, in the late 1820s plans were drafted to replace the existing fort with a masonry citadel; construction for the new fortification would be so extensive that by mid-century most traces of the original structures were completely removed. Evidence of the site's earliest occupation would not re-emerge until the mid 1990s, when archaeological testing uncovered foundations pre-dating the second Fort Henry. Since then, historical research and excavations by Parks Canada have revealed more about the first fort's boundaries, architecture, and something of its builders and garrison. This essay presents some preliminary glimpses of the first Point Henry complex and discusses areas with potential for future research.*

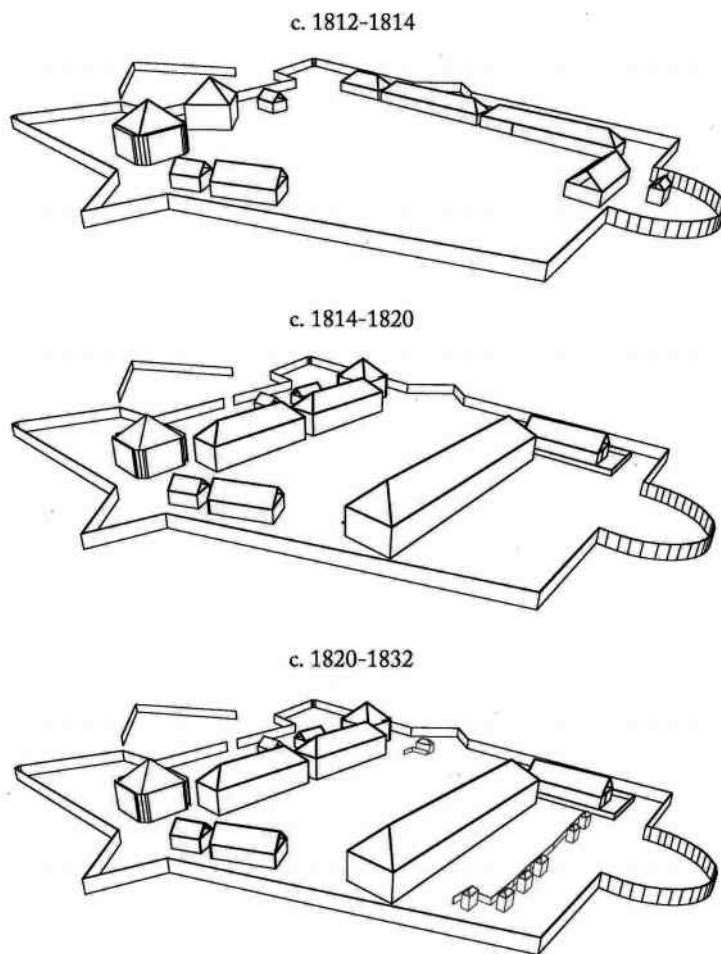
**Figure 2.** *The evolution of the first fort interior architecture (reconstruction by H. Cary).*

The trace remained virtually unaltered throughout the fort's history while numerous changes were made inside the work (Figure 2). By 1814, three long barracks probably of log construction were located on the eastern side, and on the west two small wood buildings and a 50x50 foot (15.24x15.24 m) stone defensible tower had been constructed. Two wood structures were placed within the demi-lune battery, and the 1812 blockhouse still stood in the north.

gone and in their place stood another 50 foot square stone defensible tower, followed in 1816 by a 78x32 foot (23.8x9.75 m) stone *powder magazine* with surrounding *blast wall* in the southeast corner. Between the towers, and oriented east-west, were two 111x30 foot (33.8x9.1 m) two-storey masonry soldiers' barracks constructed between 1819 and 1820. On the same axis to the south a 233x40 foot (71 mx12.2 m) two-storey stone officers' barracks was added in 1820. By the late 1820s some of the earlier wood buildings still survived, notably the guardhouse near the north gate and a stable in the west centre, and several stone privies had been built; one

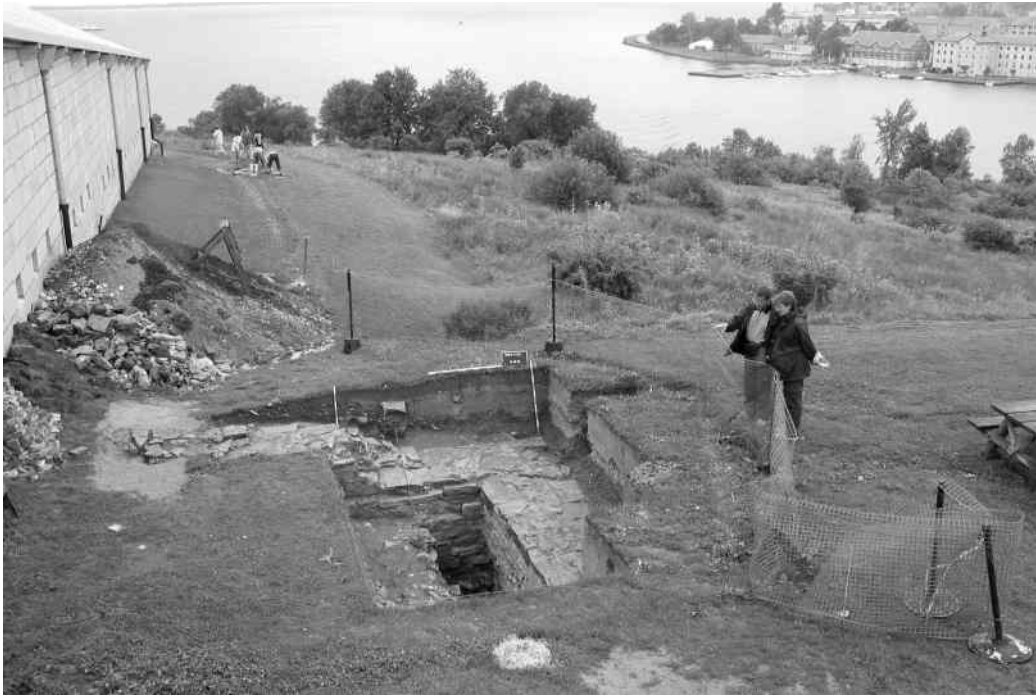
**Figure 4.** Excavations on the southwest corner of the 1820 Officers' Barracks, facing south. (Photo 131H653E by H. Cary).

Limited excavations of the officers' barracks—just 2.8% of the total structure—revealed a surprising amount about the building's construction and its inhabitants. The foundations provide an introduction to the structure's scale: robustly built using two parallel *wythes* of squared limestone rubble, averaging 40x15 cm in size and infilled with rubble and mortar, the walls are 1.15 m to 1.20 m wide on the south façade, and 1.10 m wide on the west gable end (Figure 4). Between one-third and halfway up the excavated interior of the south façade the masonry narrows to 1 m in width, creating an 8-20 cm wide ledge. This step construction centres the vertical and lateral thrust from the upper wall sections and roof, and probably also supported interior floor joists. The façade wall foundation was laid directly on the sloping surface of bedrock and rises in elevation towards the centre of the structure and the summit of Point Henry. Conversely, the gable wall foundation was laid against a vertical cut in the bedrock, and built tall to account for the rising façade wall. Despite this added height, neither the gable or façade foundation would have been visible during the occupation period. The walls' exterior was covered by successive layers of rubble, mortar, and clay, some of which relate to the barrack's construction and others that were used to landscape around the foundations. These fills were laid periodically over the structure's lifetime and one of the top-most layers contained granite that probably came from the Redoubt defensive ditch in 1832.

Fill was not similarly deposited inside the barracks. If the interior ledge on the façade wall did support floor joists, there was a crawlspace at the gable end that varied from 0.55 m to 1.20 m high, but one that diminished towards the centre of the building, 30 m away, because of the rising bedrock elevation. Bonnycastle and Smith's

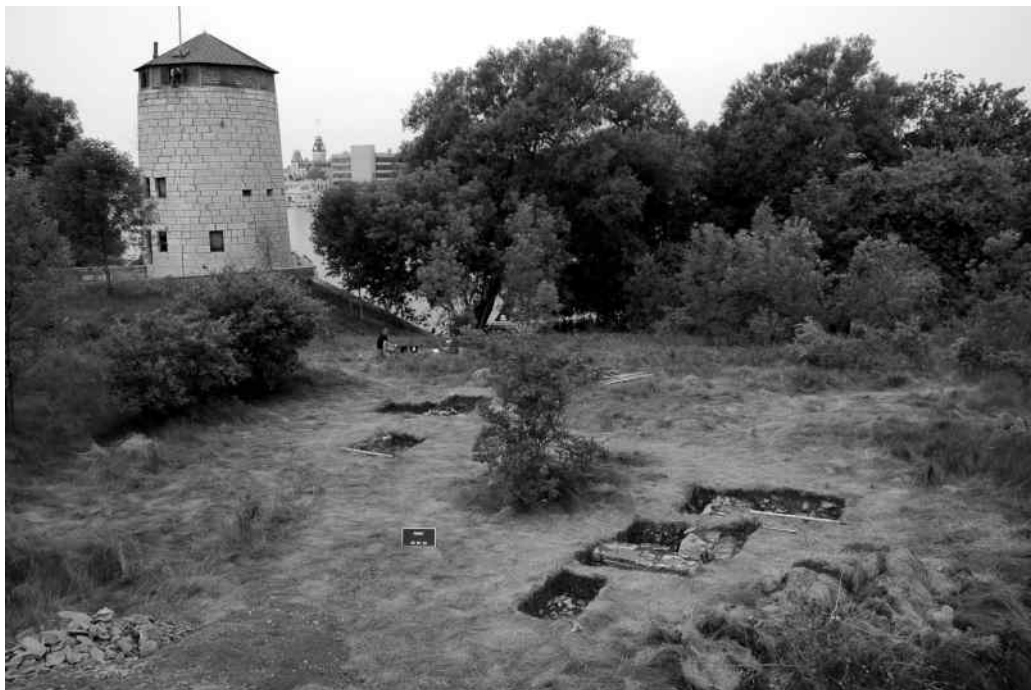
**Figure 6.** Excavations on the 1819 Guardhouse, facing west. On the left is the West Branch Ditch Tower of the second fort (Photo 131H986E by H. Cary).

On the plain immediately north of the West Branch Ditch several stones around a low square mound (Figure 6) were noticed on the surface. Three units were dug on the mound's perimeter and revealed two corners of a 50-70 cm wide coursed limestone rubble foundation. From these corners the structure's dimensions were determined to be 23.5x21.6 feet (7.18x6.5 m), conforming very closely to the 23x21 feet listed for the Ordnance Yard's one-storey stone guardhouse built in 1819 (Garcia 2006:89). The walls still stood up to 95 cm high and had been laid with copious amounts of mortar within a narrow

trench cut 40-50 cm through natural soils. On the interior side of the east wall, notches spaced 65 cm apart still supported 8-12 cm squared wood joists that would have braced the floor boards. Plaster found within the foundations indicated the walls had been washed in a light brown colour.

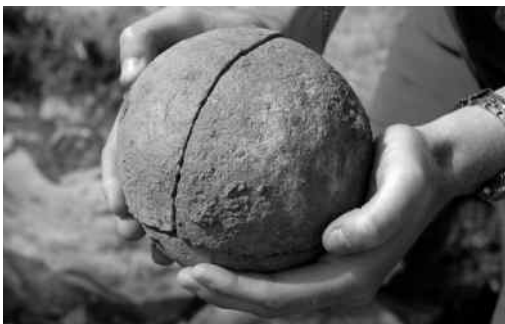
**Figure 7.** The “12-pounder” cannonball unearthed outside the guardhouse. Note where it has fractured into three fragments (Photo 131H930E by H. Cary).
